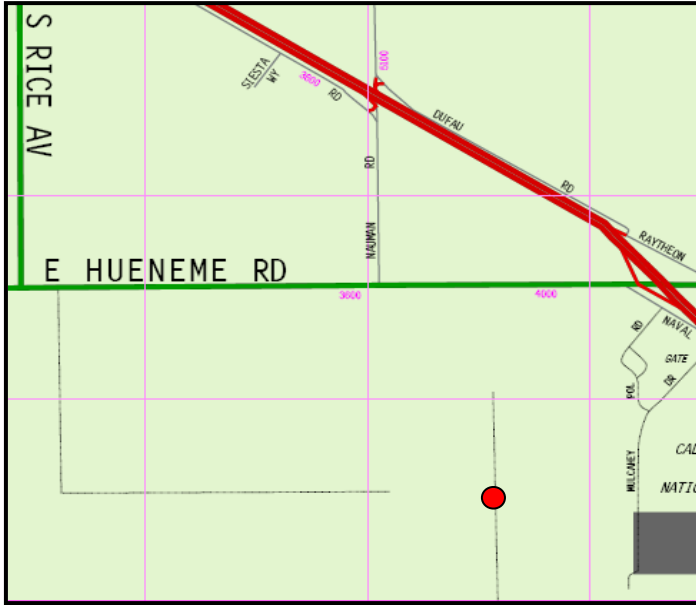
01T_ODD2_DCH

Duck Pond Agricultural Drains / Mugu Drain / Oxnard Drain No. 2. The monitoring site is located on an agricultural drain just south of Hueneme Road near the Duck Ponds. Flow from this drain eventually discharges into the western arm of Mugu Lagoon (Calleguas Creek Reach 1).

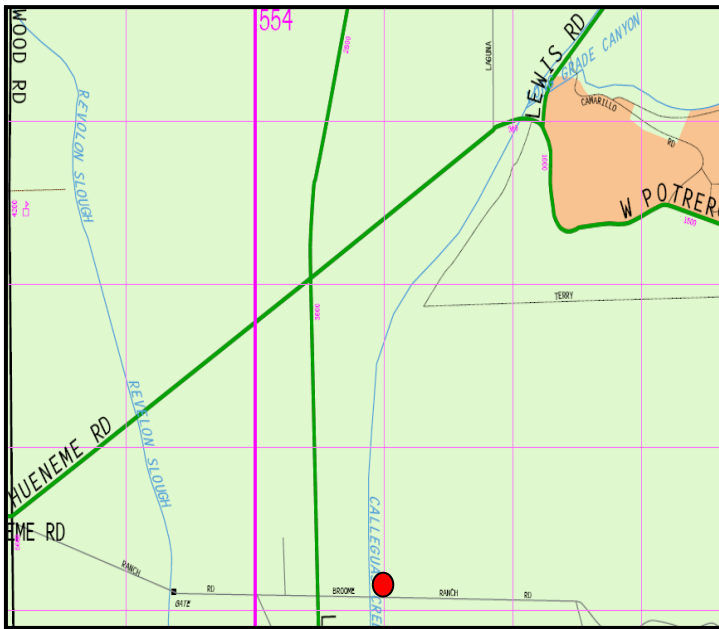
02D_BROOM

The monitoring site is located on an agricultural drain that discharges into Calleguas Creek Reach 2 at Broome Ranch Road.

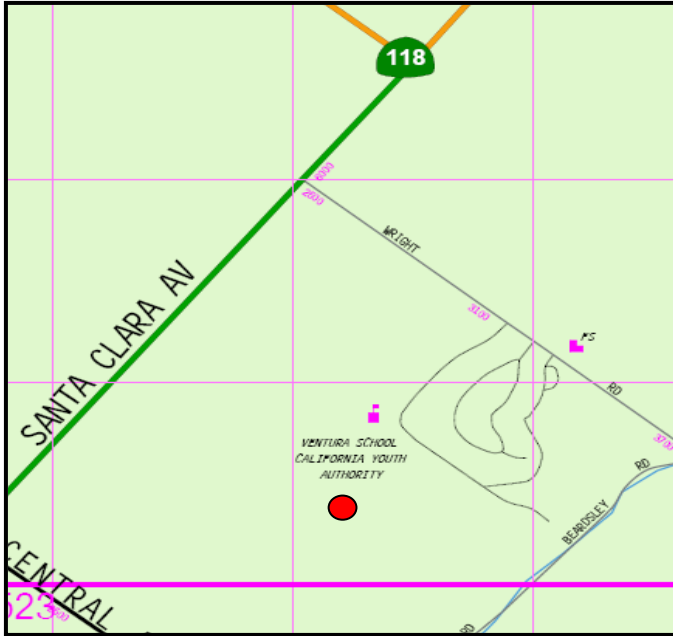
05D_SANT_VCWPD

This monitoring site is located on the Santa Clara Drain east of Santa Clara Avenue at the Ventura County Watershed Protection District's Stream Gage #781. Flow from this drain eventually discharges into Calleguas Creek Reach 5 (Beardsley Channel).

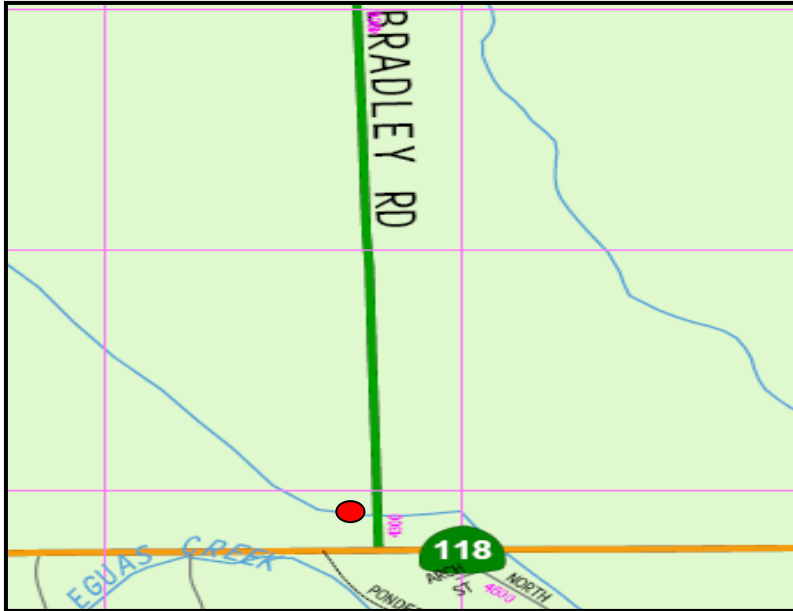
06T_FC_BR

This monitoring site is located on Fox Barranca just upstream of the Bradley Road bridge, north of Hwy 118. Fox Barranca is a tributary to Calleguas Creek Reach 6 (Arroyo Las Posas).

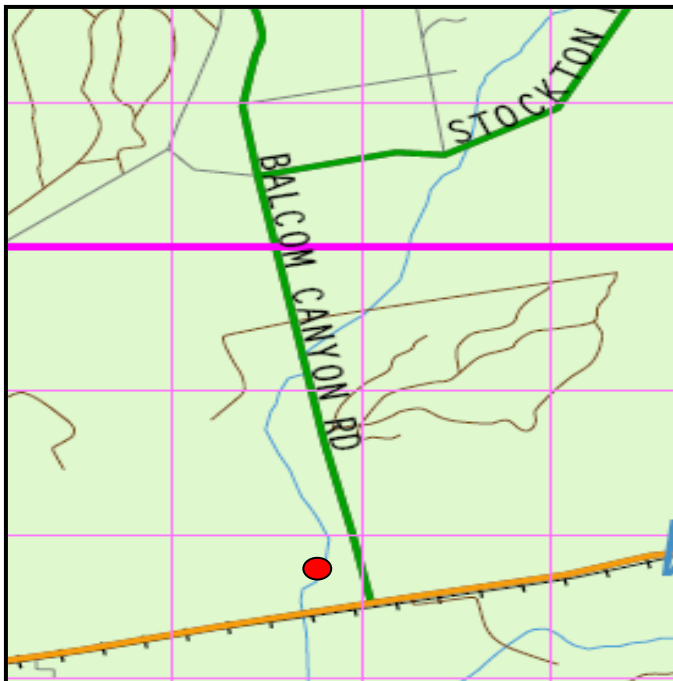
06T_LONG

This monitoring site is located on Long Canyon just upstream of the Hwy 118 Bridge. Long Canyon is a tributary to Calleguas Creek Reach 6 (Arroyo Las Posas).

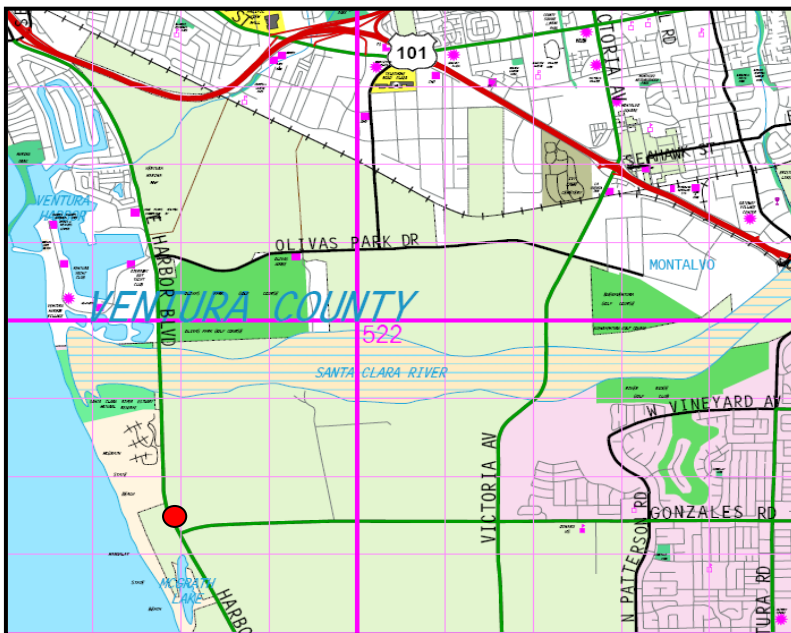
OXD_CENTR

This is the only VCAILG monitoring site in the Oxnard Coastal Watershed. The site is located on the Central Ditch, which flows under Harbor Blvd and into McGrath Lake. Water from McGrath Lake is pumped periodically into the ocean to prevent the Central Ditch from backing up and flooding Harbor Blvd.

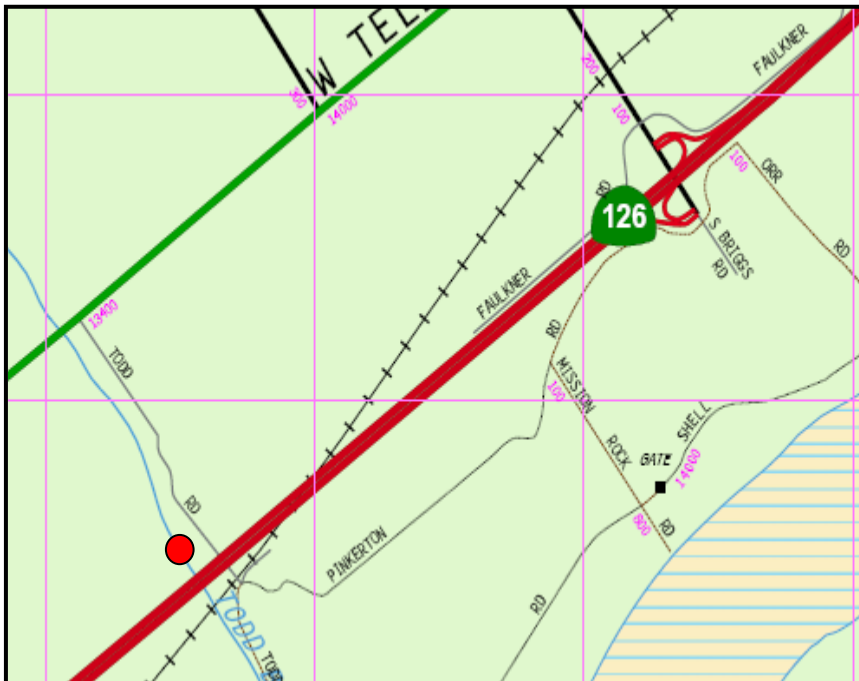
S02T_TODD

This monitoring site is located on Todd Barranca upstream of Hwy 126. Todd Barranca drains the Wheeler Canyon area and is a tributary to Santa Clara River Reach 2.

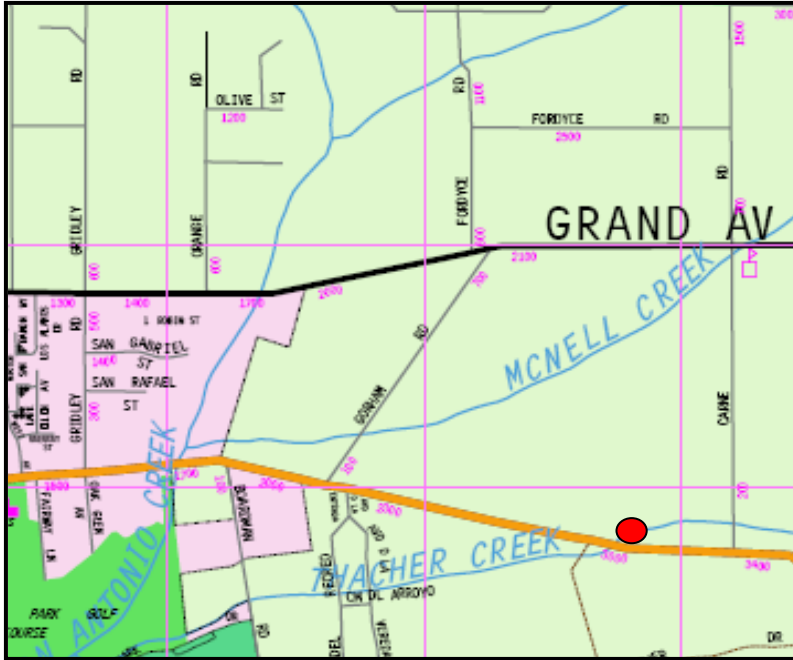
VRT_THACH

This monitoring site is located on Thacher Creek just upstream of Ojai Avenue in Ojai. Thacher Creek is a tributary to San Antonio Creek, which is tributary to the Ventura River.

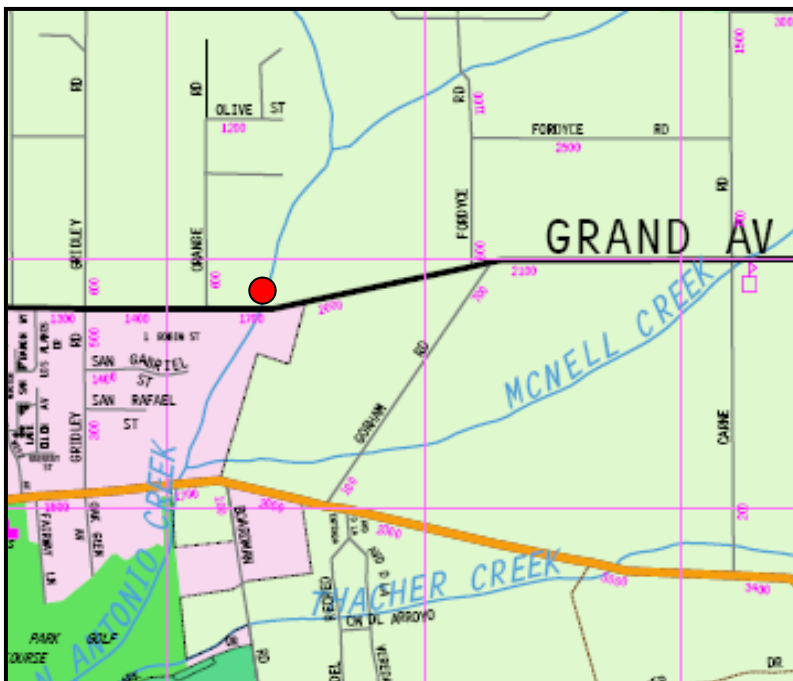
VTR_SANTO

This monitoring site is located on San Antonio Creek just upstream of Grand Avenue in Ojai. San Antonio Creek is a tributary to the Ventura River.
